1958 Jaguar XK150 remained complete, but body corrosion was extensive

Twenty years ago, an abandoned, rust-ridden Jaguar XK150 coupé was destined for the scrapyard. Thousands of pounds later, after some hard lessons, it is on the road again. Malcolm McKay drives the end result

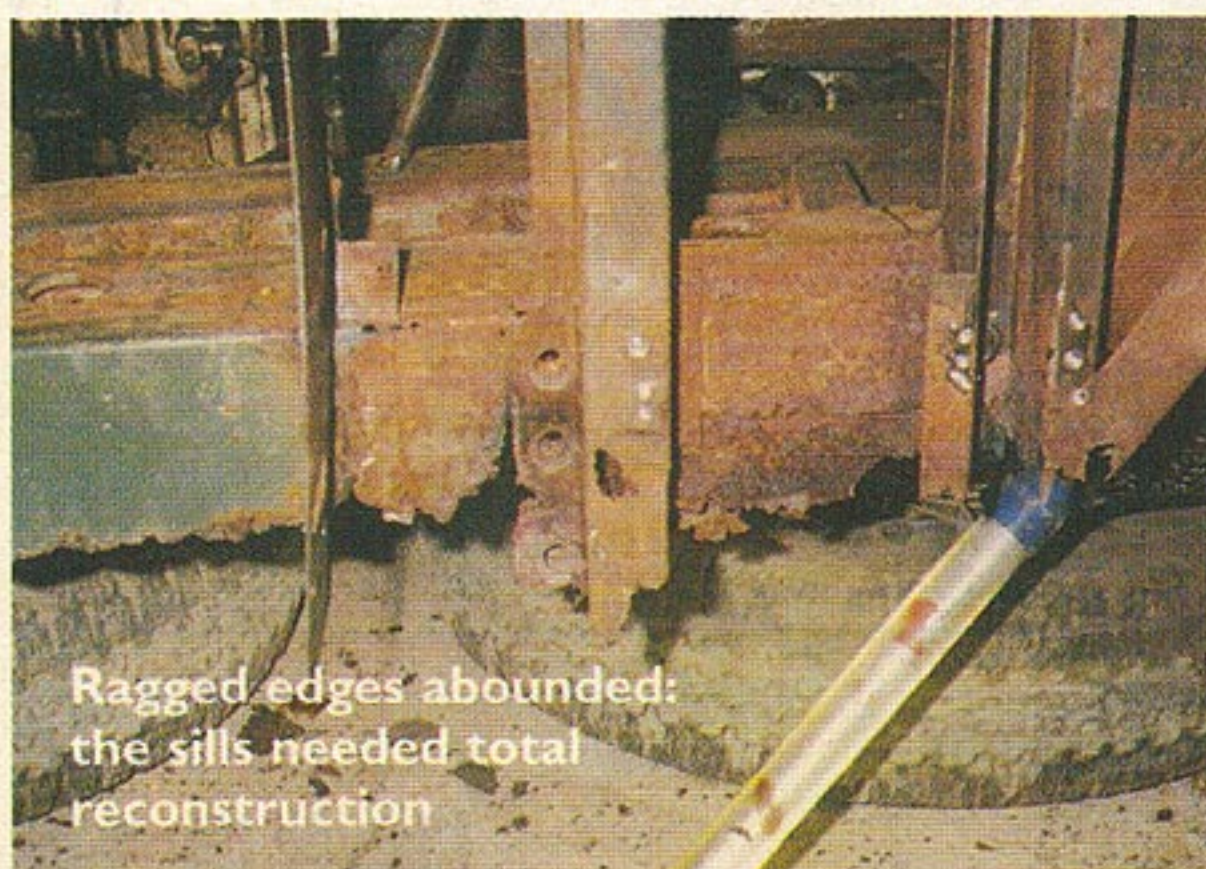
Ragged edges abounded: the sills needed total reconstruction

Recreating that sensation of refinement, speed and safety in a car that has totally rotted would challenge any restorer. With plenty of experience of Jaguar bodywork, Southern Classics was not too daunted by the task David Dalton presented to the company back in 1992. The car was stripped and the body removed from the chassis. The chassis was then stripped and sandblasted before it was painted in gloss black; it was remarkably sound. The body, however, required new rear wings, sills, doors, A-posts, inner flich panels, boot floor and major repairs to the front wings. It was so bad that it was separated into several sections during the rebuild.

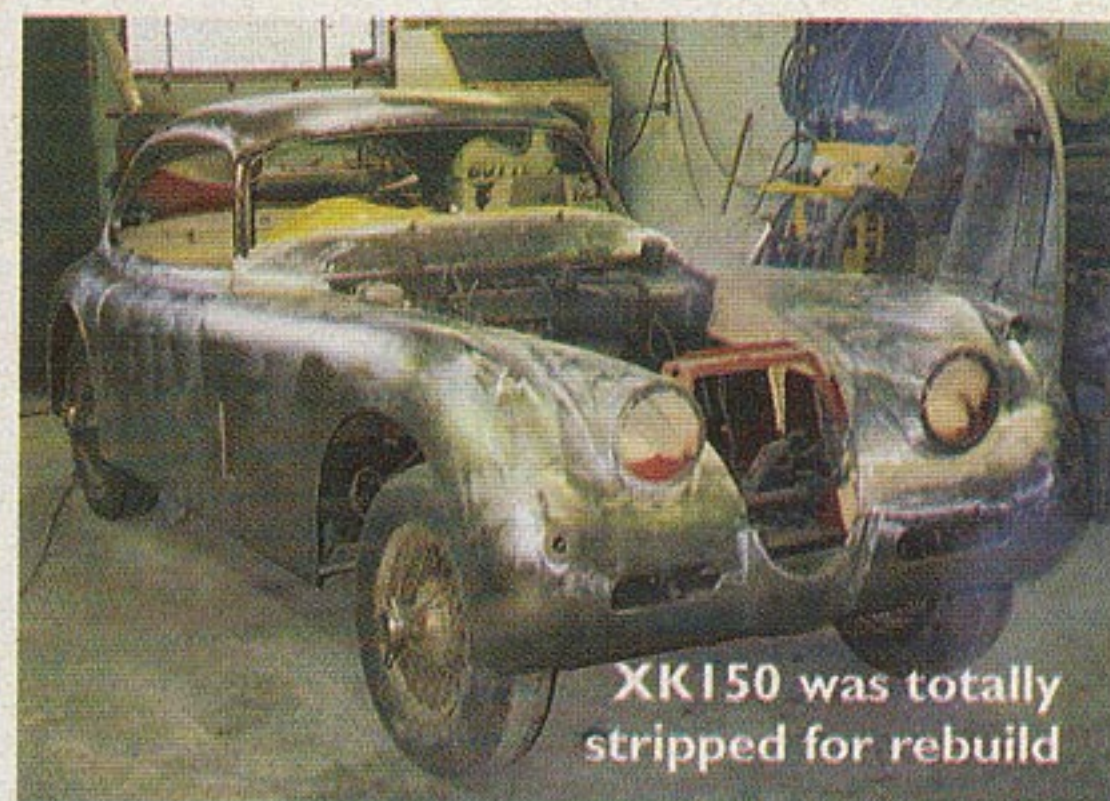
XK150 was totally stripped for rebuild

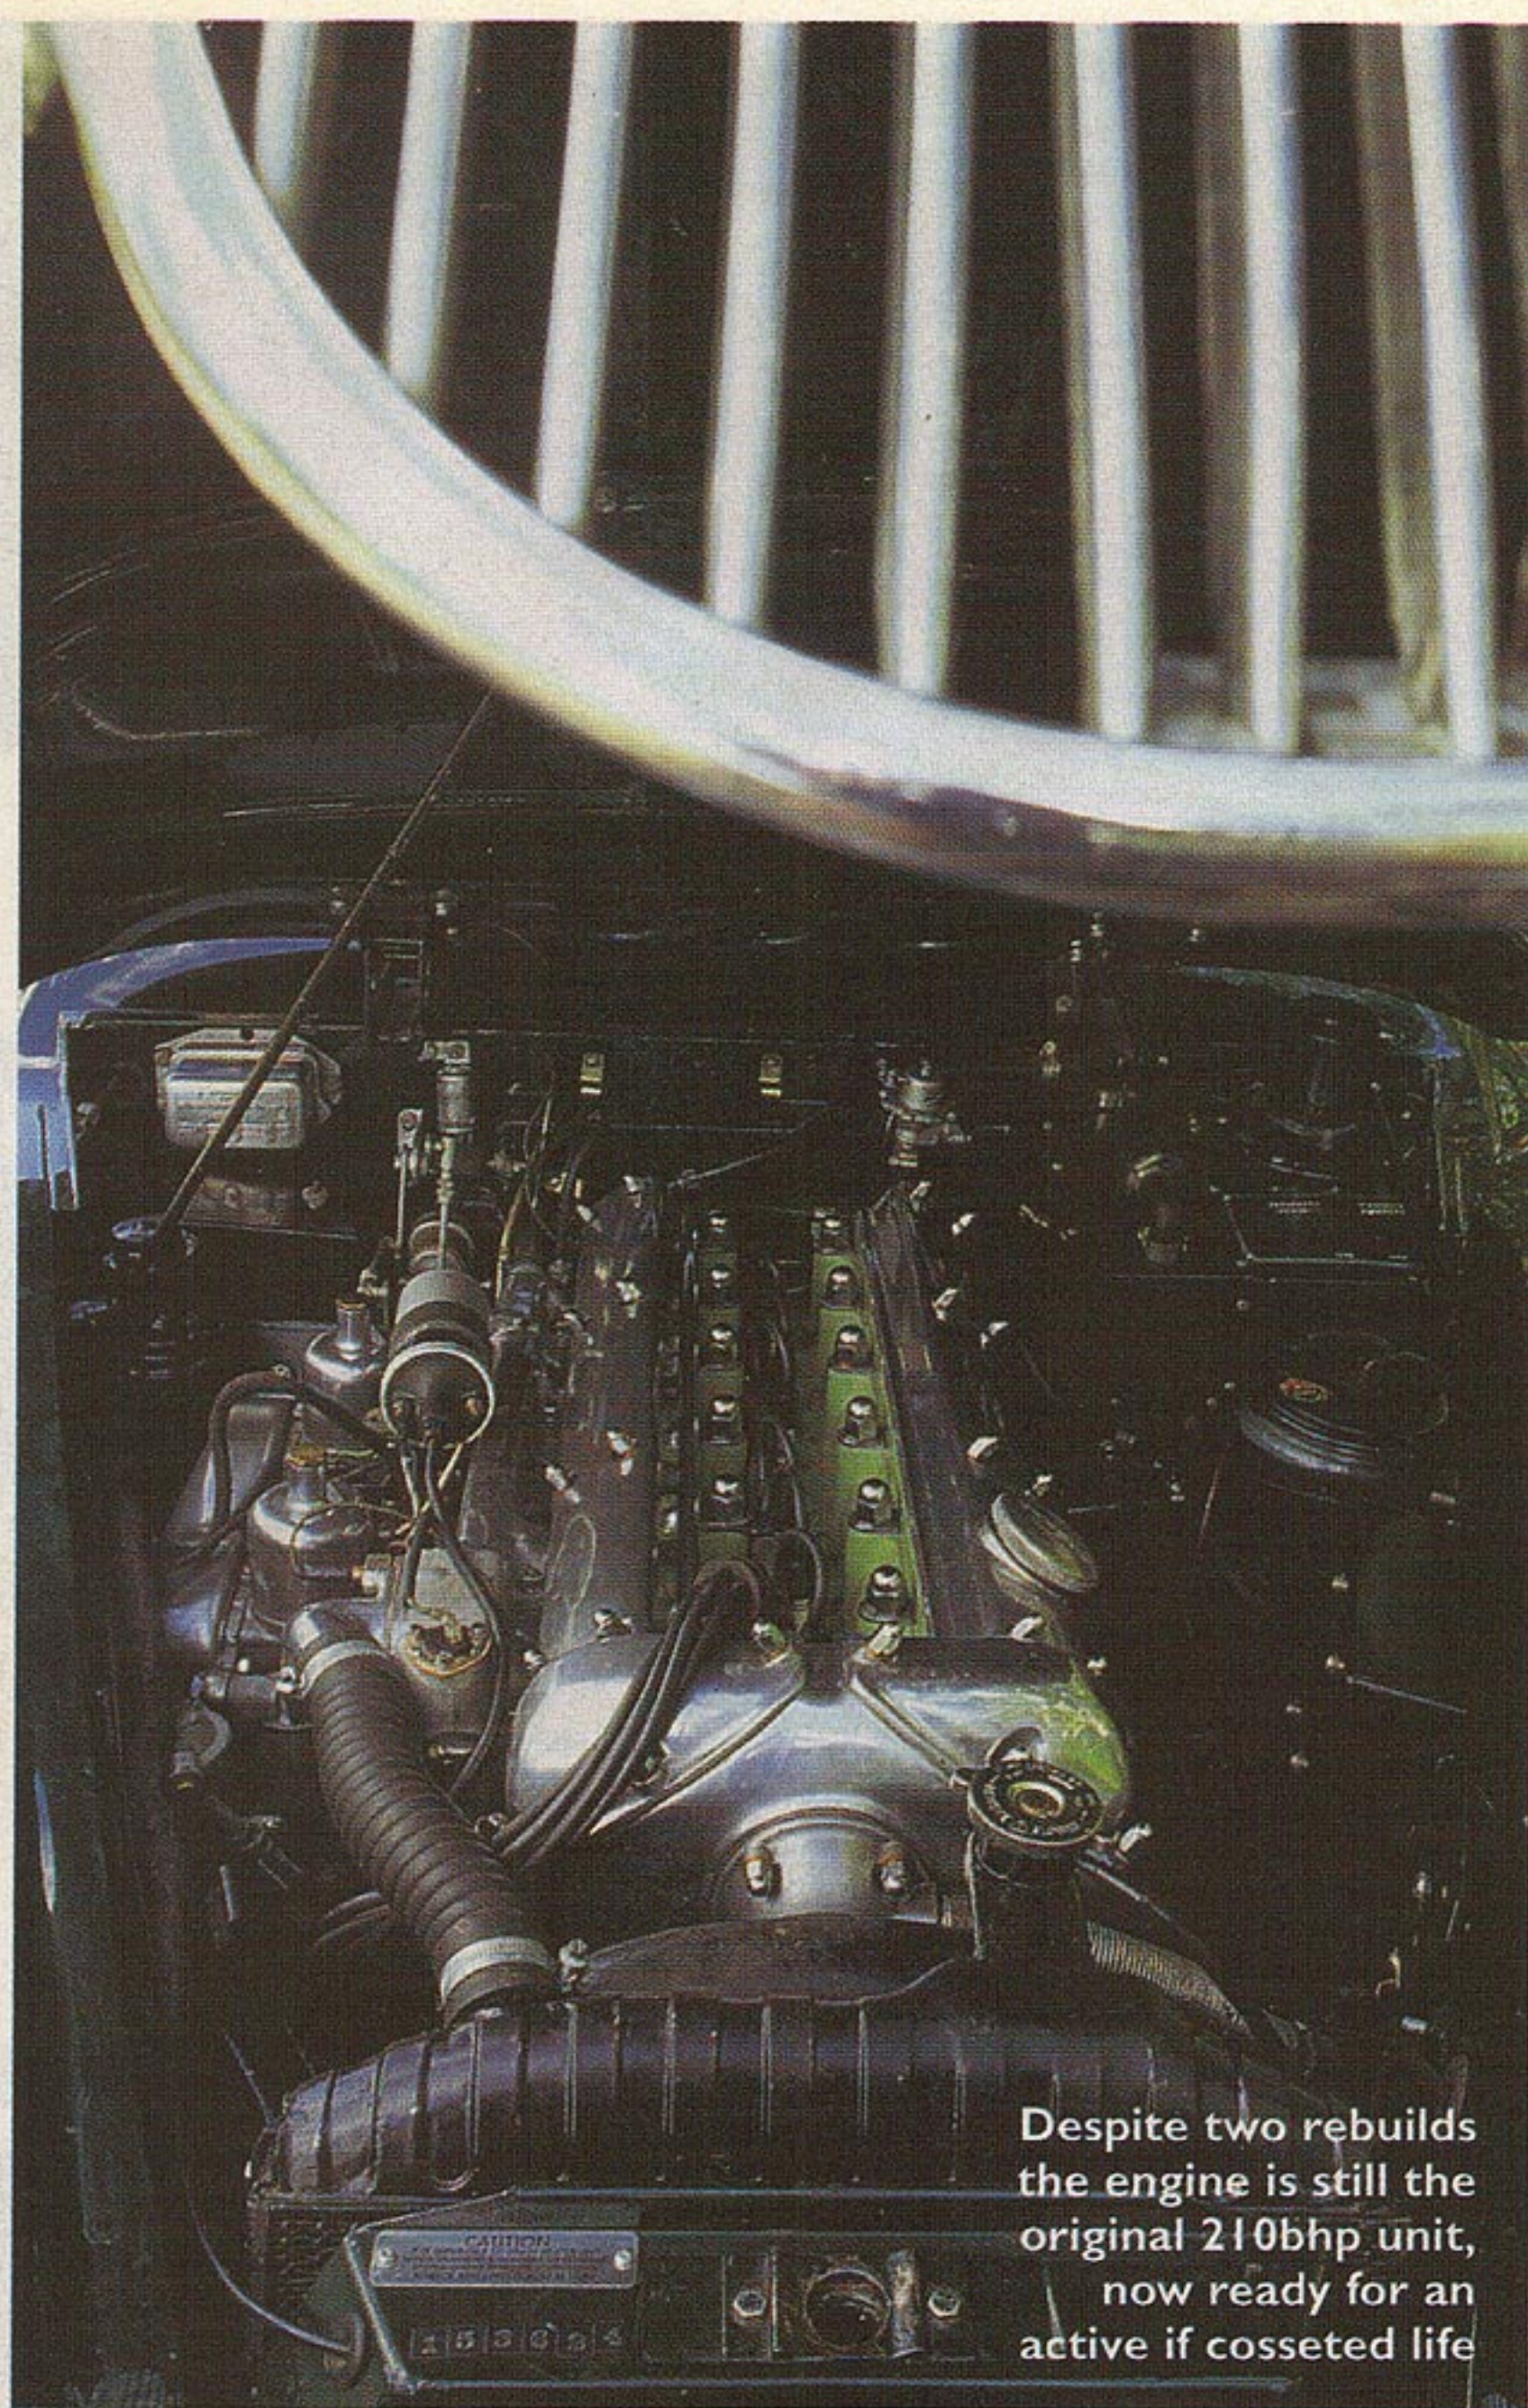
The engine was the most expensive mistake; having dismantled it and had it rebored, he reassembled it with the pistons back-to-front, then timed the inlet valves only, thinking the exhausts would automatically follow. However, the twin camshafts had moved out of synchronisation during dismantling and when the engine was run, valves hit pistons with expensive consequences. Southern Classics found one cylinder had been bored out of true as well and had to have it lined, so David would soon have encountered problems anyway.

Despite two rebuilds the engine is still the original 210bhp unit, now ready for an active if cosseted life

David's plan was to carry out mechanical restoration work and trimming himself. Some of this he did, but once the engine rebuild went wrong, he bit the bullet and returned the car to Southern Classics, who sent the engine away for

a second rebuild, fitted a new headlining, carpets and sundry trim items and ran through the numerous bits and pieces needed to bring the car up to perfect order, such as a set of splined hubs to eradicate nasty clonks from the worn originals. Including £2350 for the engine, this added a further £11,000 to the bill. Over a five-year period, David ruefully admits to having spent no less than £50,000 on a car that, as yet, he has driven only a couple of miles.

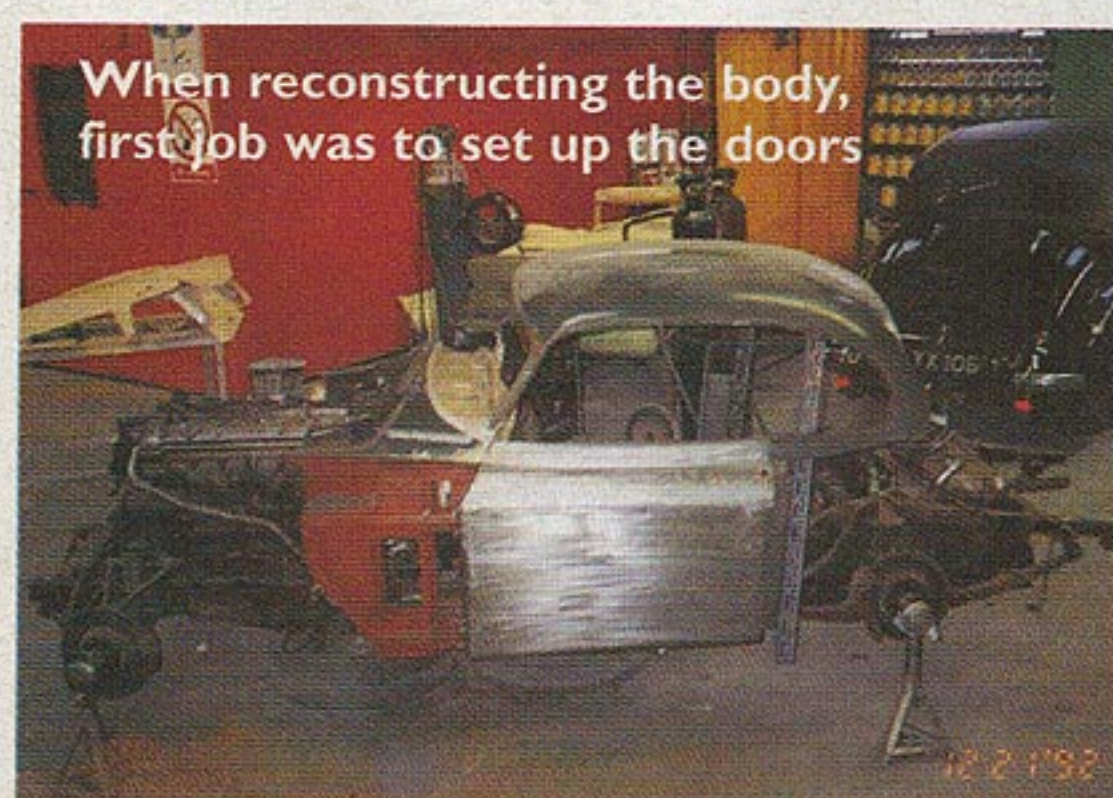
When reconstructing the body, first job was to set up the doors

Steve Berry, was working with poor quality remanufactured parts – especially door rubbers and seals, which prevent panels from fitting correctly. The way to get the superb panel alignment, he says, is to start with the doors. Getting the doors square to the sills and the sills square to the chassis is the vital first step, explains Steve, before attempting to fit the wings, bonnet, bootlid and so on.

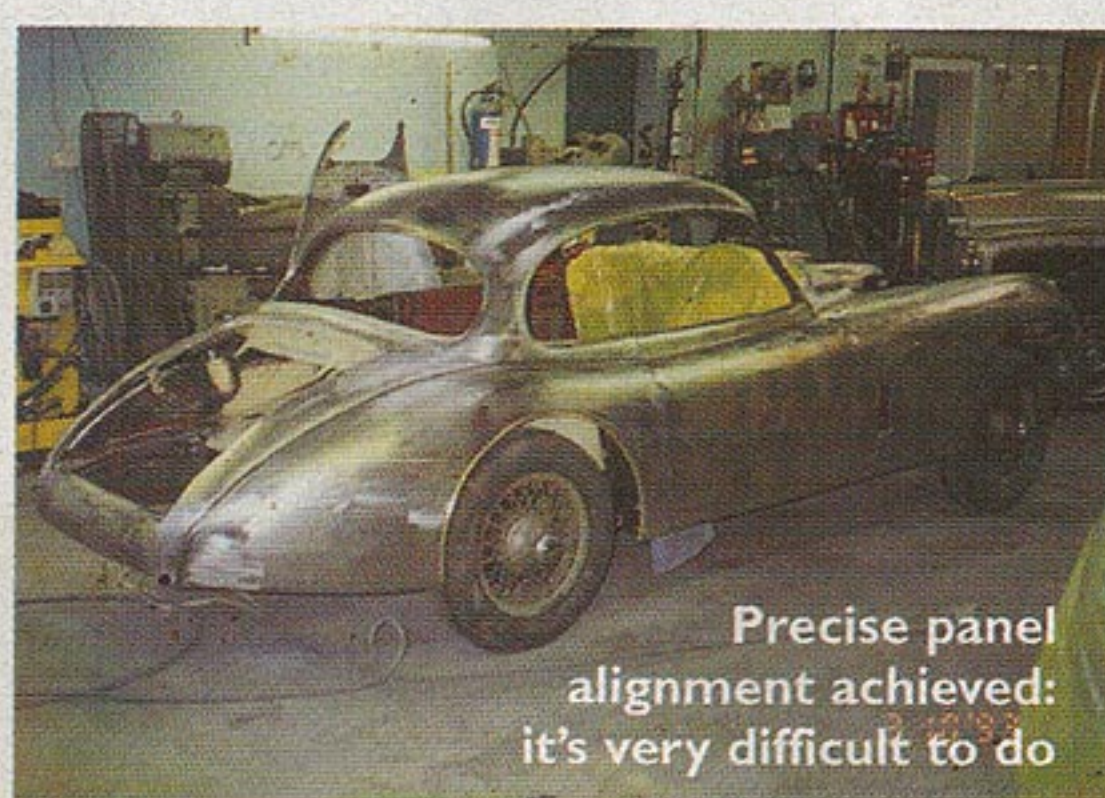
Precise panel alignment achieved: it's very difficult to do
