1958 Jaguar XK150 remained complete, but body corrosion was extensive

Twenty years ago, an abandoned, rust-ridden Jaguar XK150 coupé was destined for the scrapyard. Thousands of pounds later, after some hard lessons, it is on the road again. Malcolm McKay drives the end result

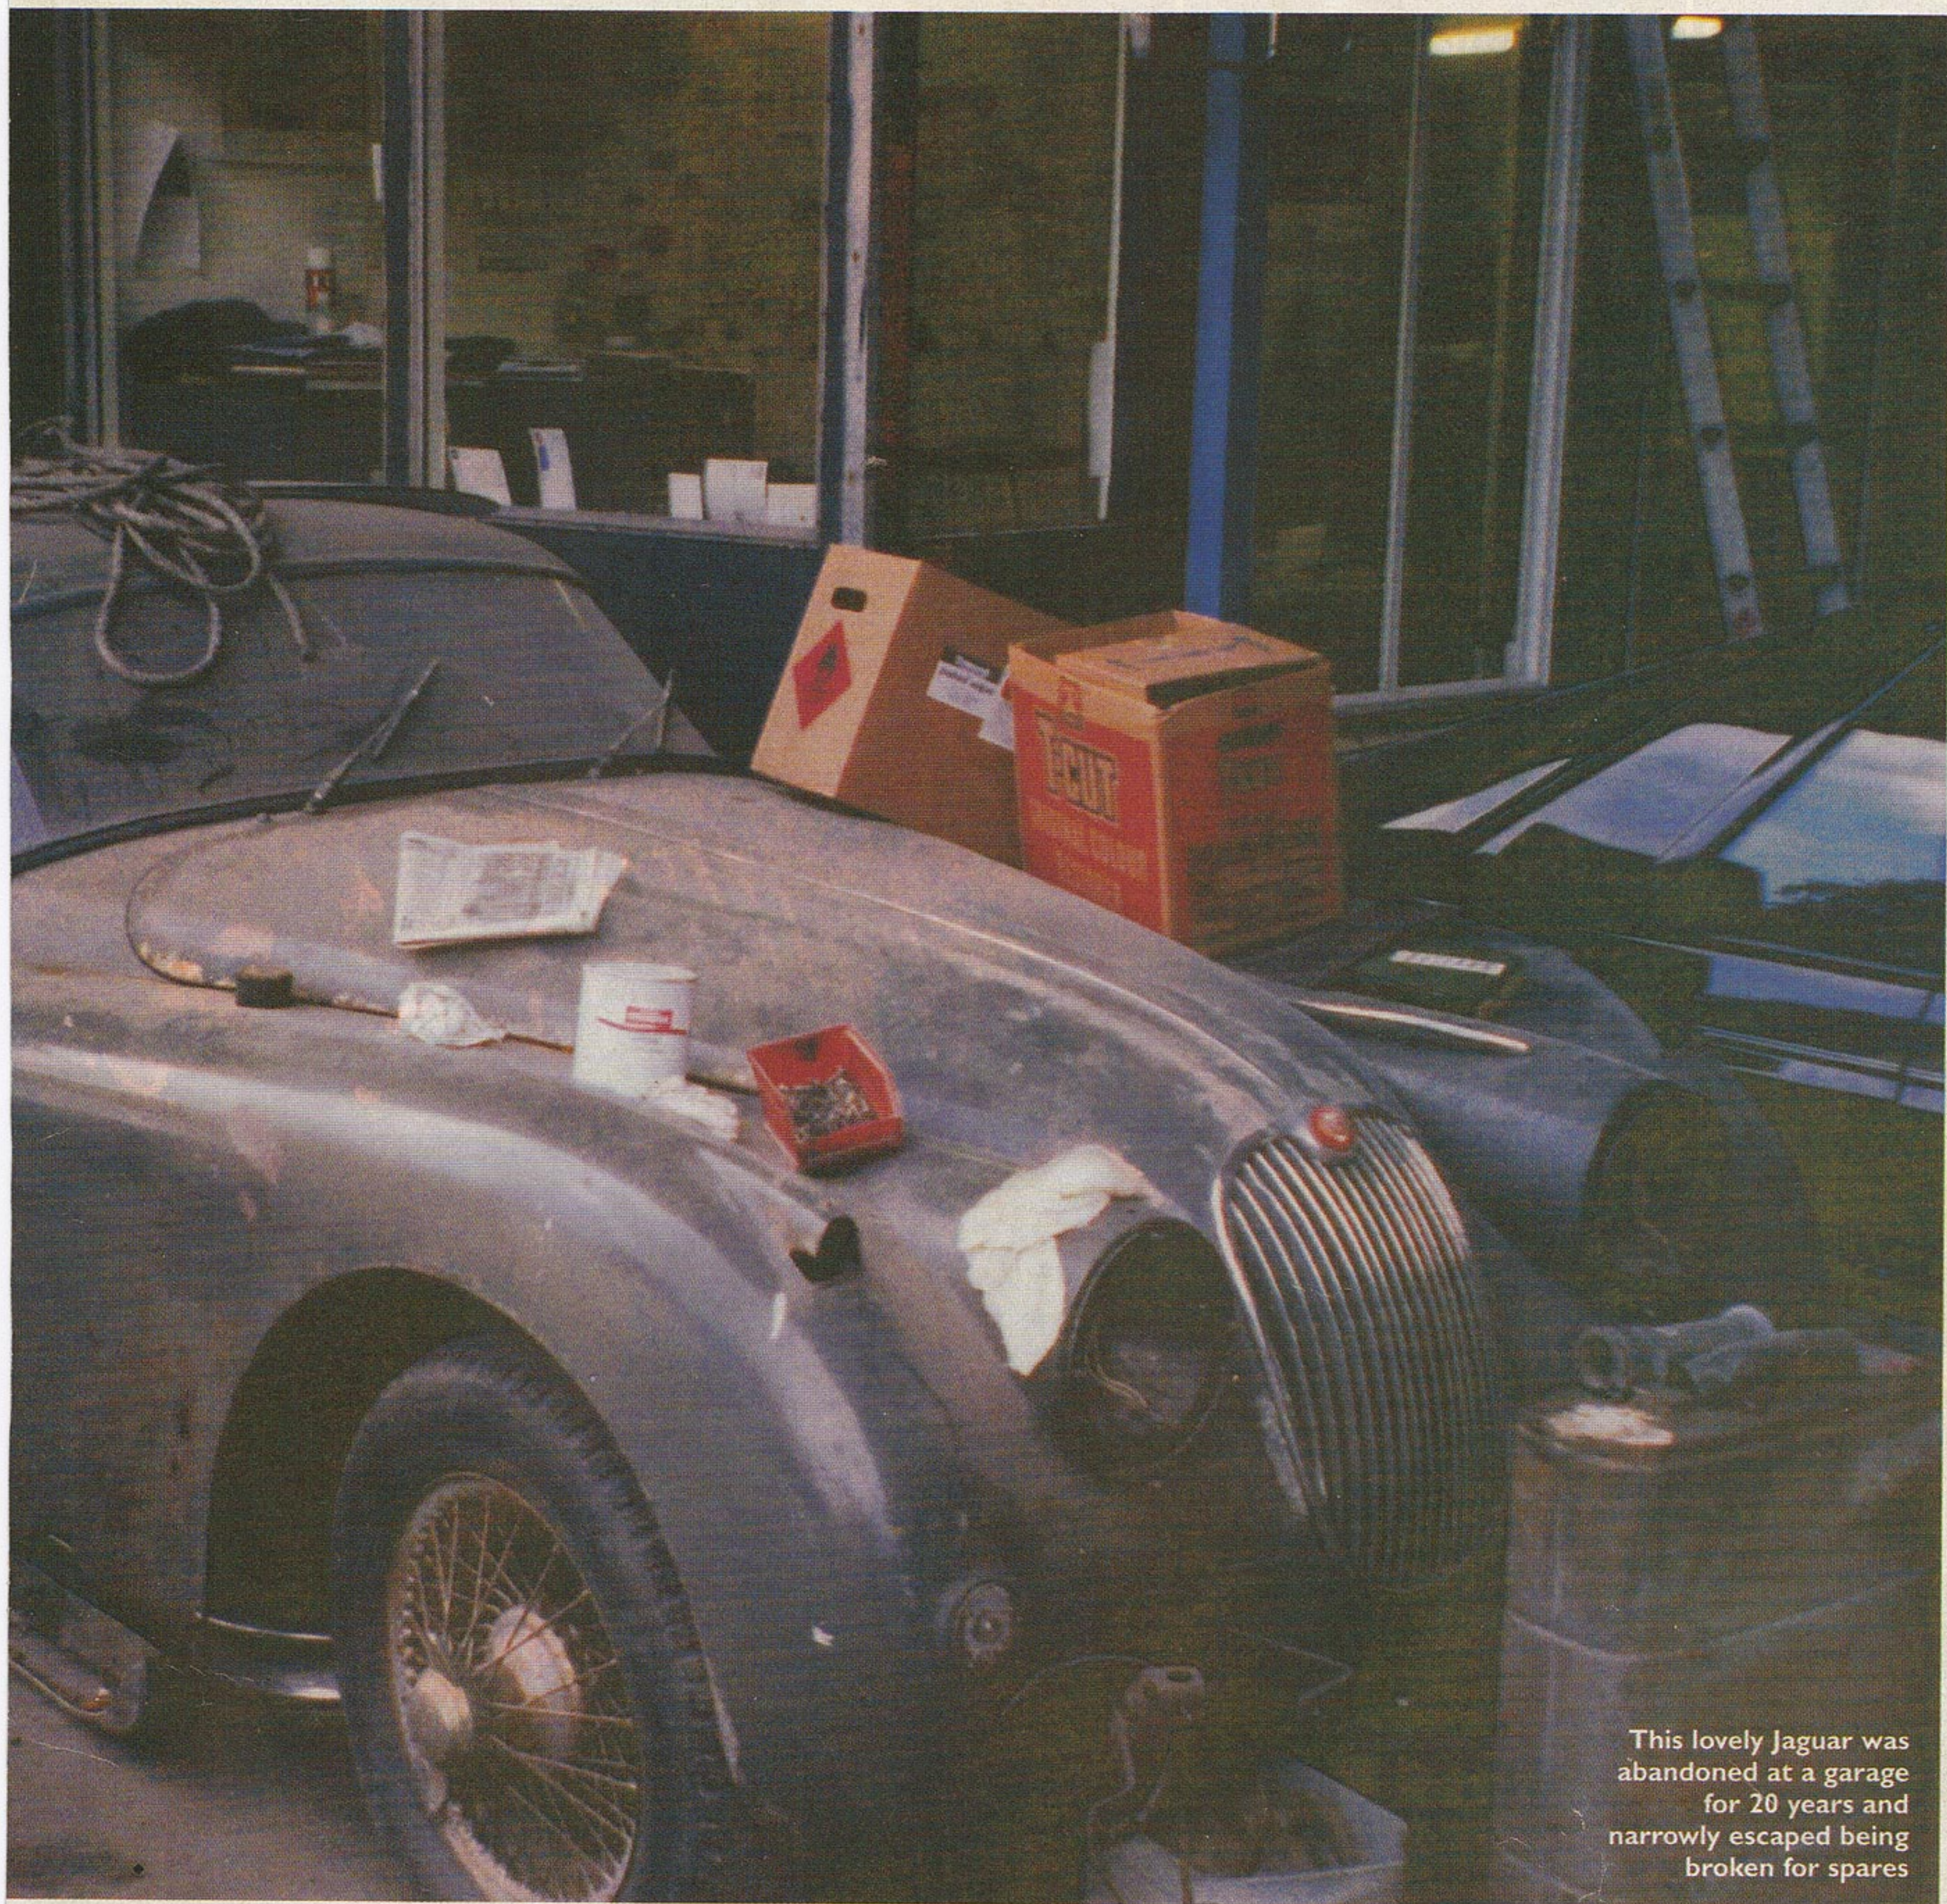
Ragged edges abounded: the sills needed total reconstruction

Recreating that sensation of refinement, speed and safety in a car that has totally rotted would challenge any restorer. With plenty of experience of Jaguar bodywork, Southern Classics was not too daunted by the task David Dalton presented to the company back in 1992. The car was stripped and the body removed from the chassis. The chassis was then stripped and sandblasted before it was painted in gloss black; it was remarkably sound. The body, however, required new rear wings, sills, doors, A-posts, inner flich panels, boot floor and major repairs to the front wings. It was so bad that it was separated into several sections during the rebuild.
